Subject: Luxembourg (ELLX), Luxembourg

VFR Charts not updated

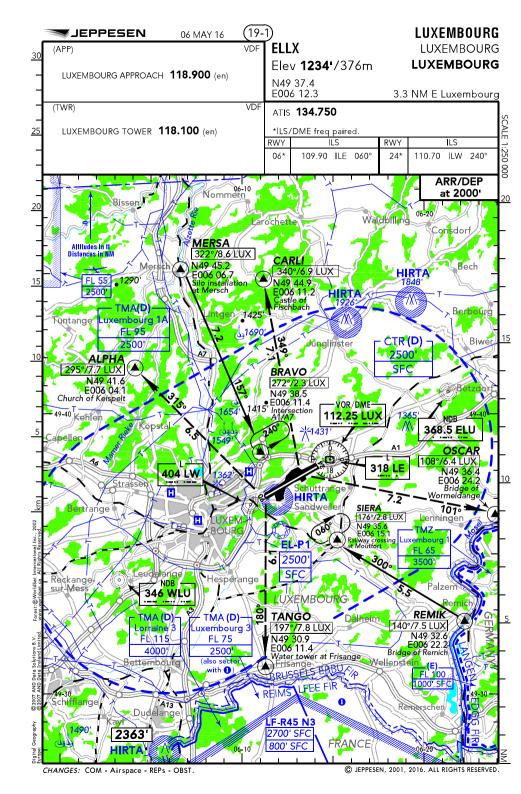
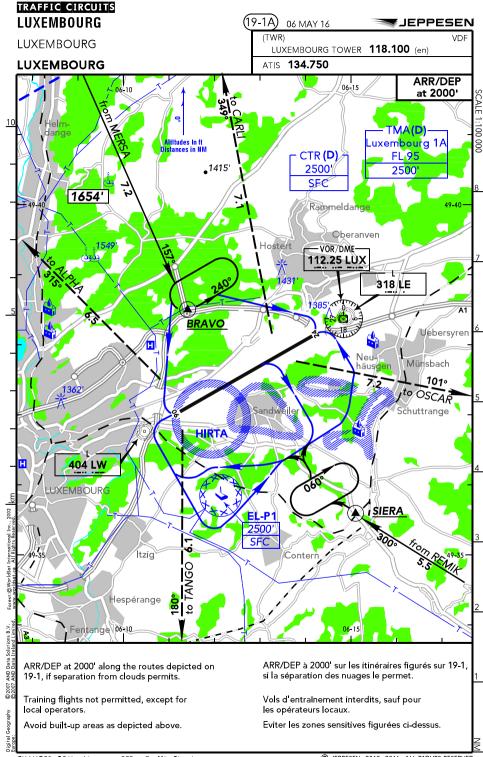
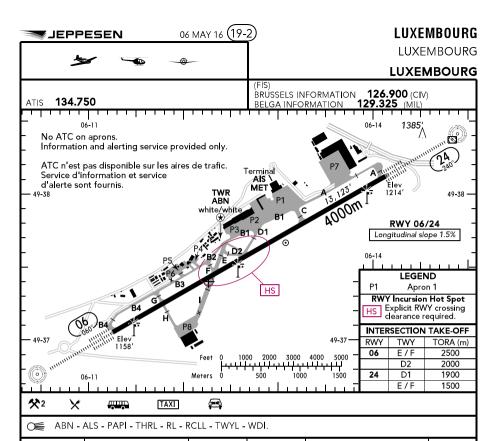
Jeppesen VFR charts for Luxembourg (ELLX), Luxembourg dated 4 JUL 14 do not contain the information published in AIRAC AMDT 003/2016 (eff. 31 MAR 16).

The corrected charts will be issued in the revision of 6 MAY 16 and are attached to this Alert.
